## Glass in Building and Nickel Sulphide

### Glass Breakage

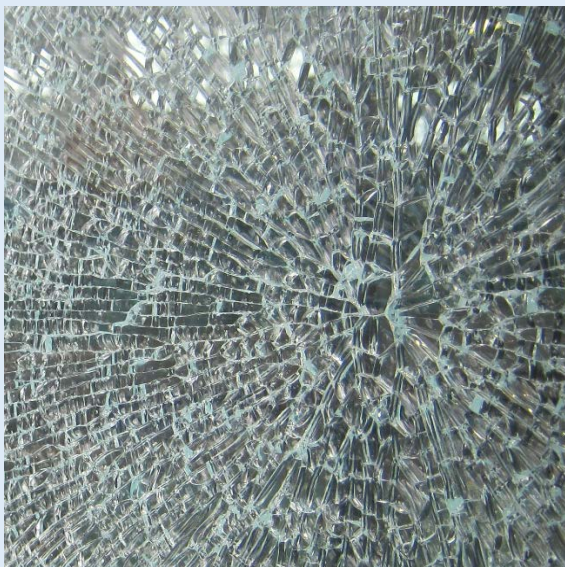
Toughened glass always displays a characteristic breakage pattern when it remains in place, which appears like the spokes of a bicycle wheel surrounding the hub, which is the origin of the fracture.

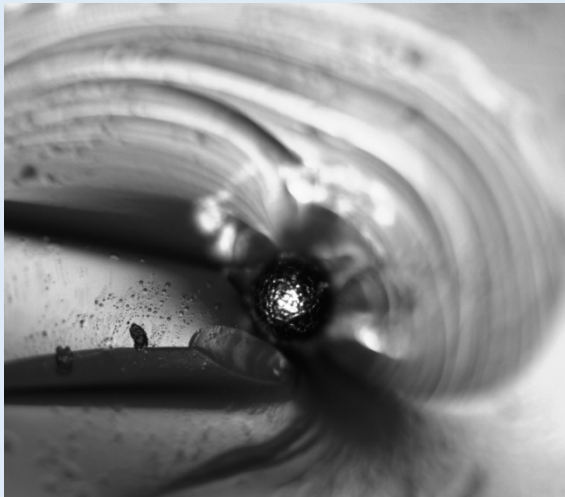
This reverse transformation to the low temperature state occurs slowly over a period of time, accompanied by a small increase in volume. If the nickel sulphide inclusion is large enough, and within the central tensile portion of the toughened glass, it can cause fracture at some time after manufacture. Commonly this period is around 3 to 5 years after manufacture, but occasionally, it may vary from 1 to 20 or more years.
