Edge Deletion

Standard Insulating Glass Unit Construction

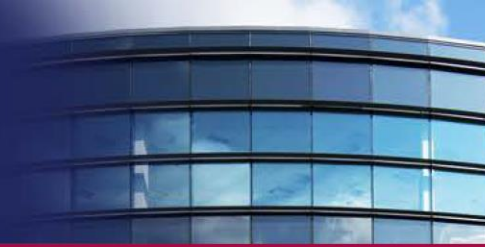
The selection of the correct edge-deletion width is very important; it is normally recommended that the coating be completely deleted around the periphery of the glass. The coating should be deleted to a width that is halfway across the primary sealant depth.

The standard sight line for insulating glass units is around 12mm +2, -2, for most unit manufacturers, which generally consists of an average 4-6mm polyisobutylene primary seal and the remainder of polysulphide, polyurethane or silicone secondary seal. 10mm edge deletion is the standard width.

If the coating is stripped beyond the primary seal, a clear band may be visible around the perimeter sightline when viewed from the inside of the building.
